Report No. FHWA-RD-75-62

DESIGN AND CONSTRUCTION OF COMPACTED SHALE EMBANKMENTS

Vol. 2. Evaluation and Remedial Treatment of
Shale Embankments

G. H. Bragg, Jr. and T. W. Zeigler

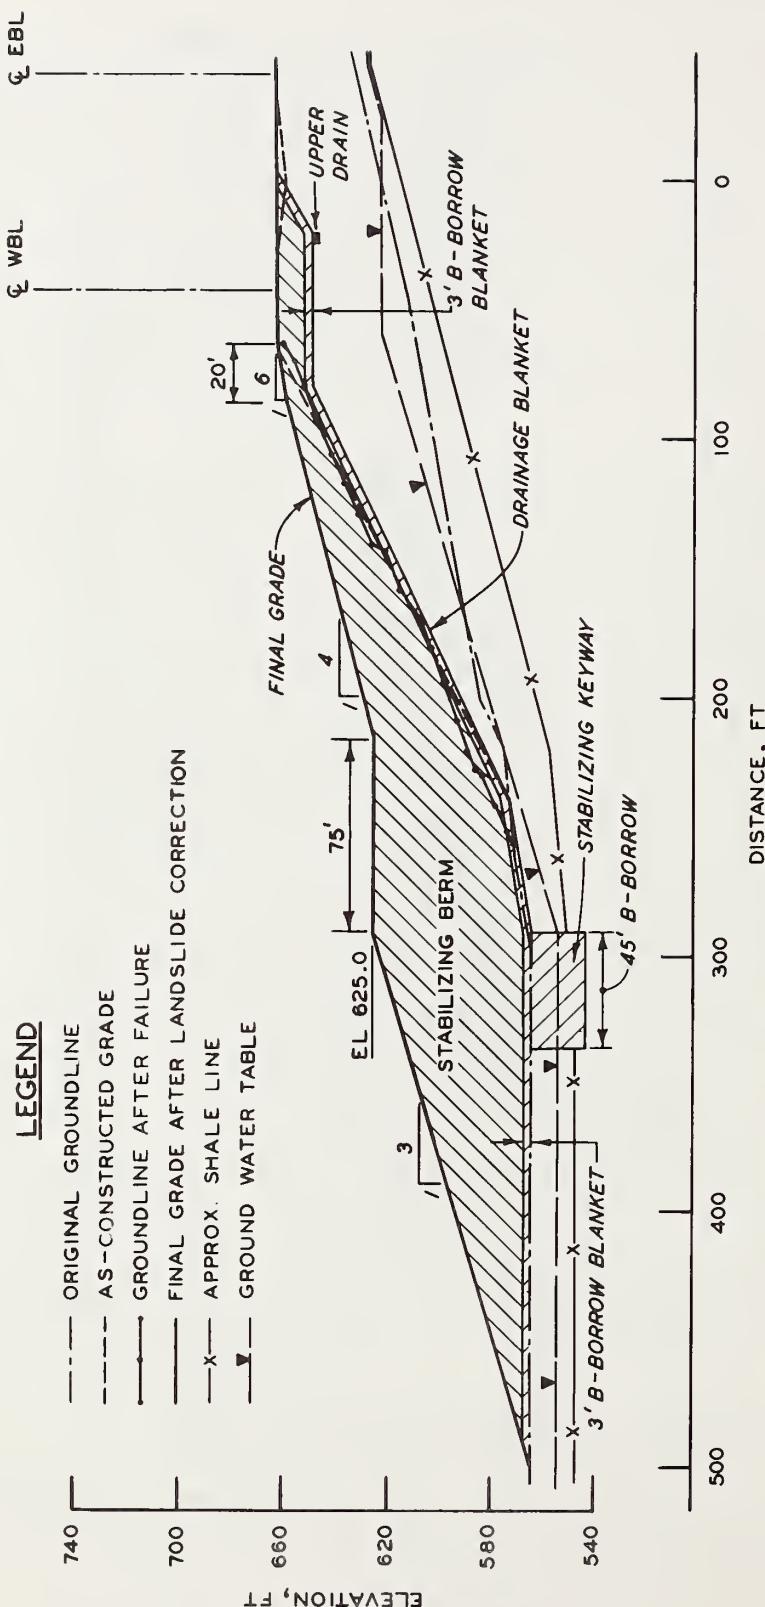
Drainage blankets have been used successfully when placed directly on the failed slope and overlain by a berm. Stabilizing berms and drainage blankets used in repair of SLIDES-1 and -2 on I-74, Indiana, are shown in Figures 59 and 60, respectively. The location of the ground line after failure indicates that only a small portion of the original embankment material was excavated prior to construction of the drainage blankets and berms. It is intended that the drainage blankets prevent subsurface seepage from the existing embankment into the newly constructed berm.

Figure 60. Remedial treatment of SLIDE-2, I-74, Indiana. Location shown in Figures 7 and 8 (courtesy of the Indiana State Highway Commission).

Slope flattening and berms generally require the acquisition of large amounts of additional borrow material and right-of-way. For example, the stabilizing berm shown in Figure 60 is extended to a distance of 260 ft beyond the toe of the original slope. Slope flattening and berms may not be feasible on sidehill fills unless the natural ground is relatively flat near the toe of the unstable embankment slope. In some cases, berms could be extended from the embankment slope to an opposing hillside. In these instances or any situation where natural drainage ditches or small streams paralleling the embankment are blocked, drainage structures will be required (for example, see Figure 59).

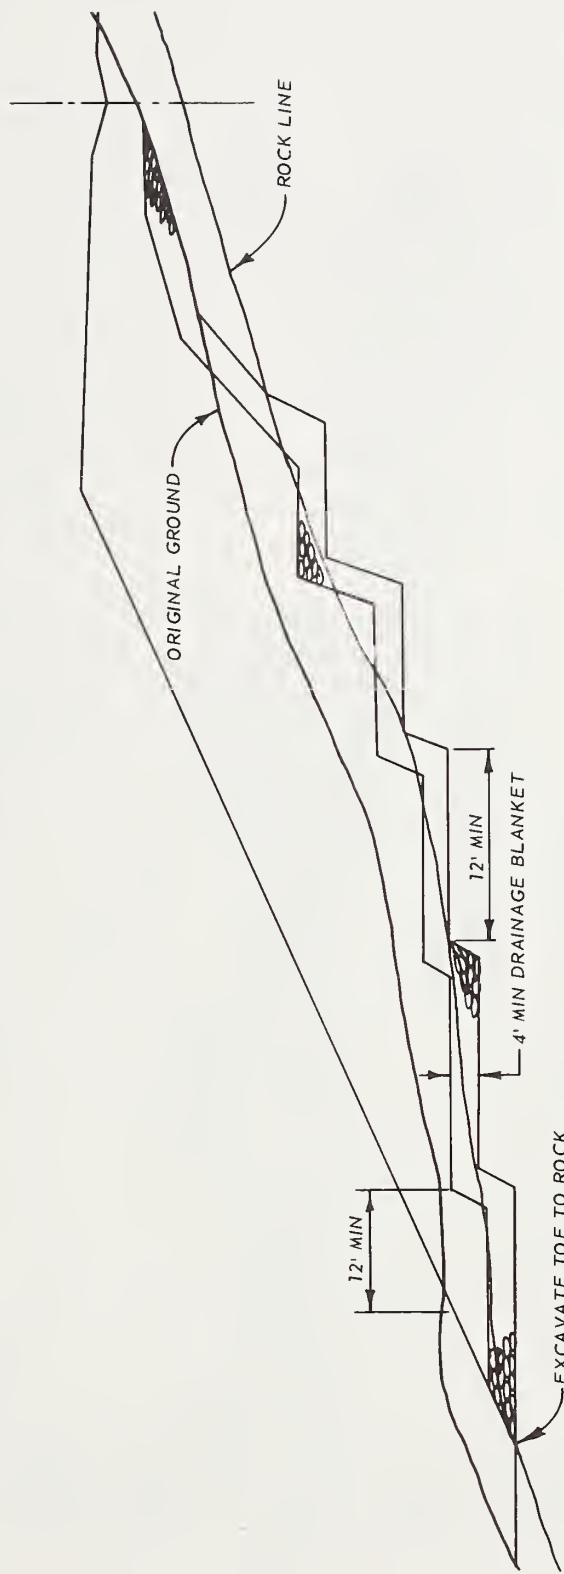
Bench drains. Remedial treatments involving reconstruction of shale fills should include removal of unstable materials (including residual soils) and benching into the underlying rock formation. Bench drains in the form of partial or fully covering drainage blankets should be placed along the benches. West Virginia utilizes a fully covering blanket as shown in Figure 61. It is advantageous to keep the blanket on the rock line as far up the slope as possible without exposing the drain to excess penetration by surface runoff. The collection of surface water by drainage blankets should be avoided since any problems with the drain will be greatly magnified by the additional volume of water. If drainage blankets must be used for drainage of surface water, special care must be exercised in design to provide sufficient capacity and protection from clogging with fines washed from the adjacent slope.

Figure 61. Drainage blanket on foundation benches as used in West Virginia (courtesy of the Department of Highways, West Virginia).

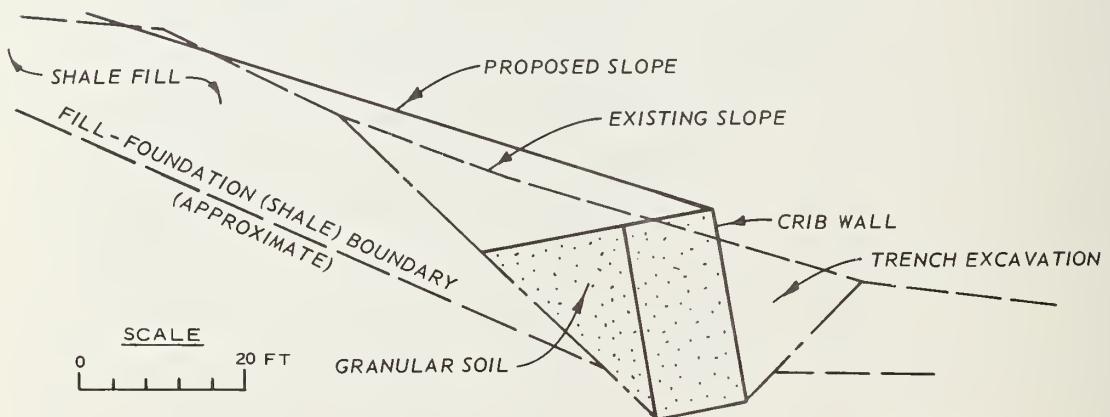
Crib walls recommended for use in stabilizing shale embankment slopes are shown in Figures 68 and 69. In these cases, the large buried portion of each wall acts as a shear key. The benefits of burying a large portion of a crib wall should be carefully determined before applying the technique. Excavation of a trench will be required as shown in Figure 69. Backfilling the trench with a granular material may provide the needed additional shear resistance, thus foregoing the expense of crib materials and construction. Of course, other factors must be considered; for example, excavation of a significant depth of soft materials may be required to reach a firm foundation for the crib wall. Also, a short section of exposed crib wall can conserve a large section of right-of-way where proposed slopes are relatively flat. In any case, trench excavation near the embankment toe could cause further distress or complete slope failure. Such excavation would probably have to be supplemented by drainage measures. Even if construction is deferred to a dry season, bracing of the trench may be necessary.

Figure 69. Alternate correction scheme, Blue Grass Parkway, milepost 21, Kentucky (courtesy of the Kentucky Department of Transportation).

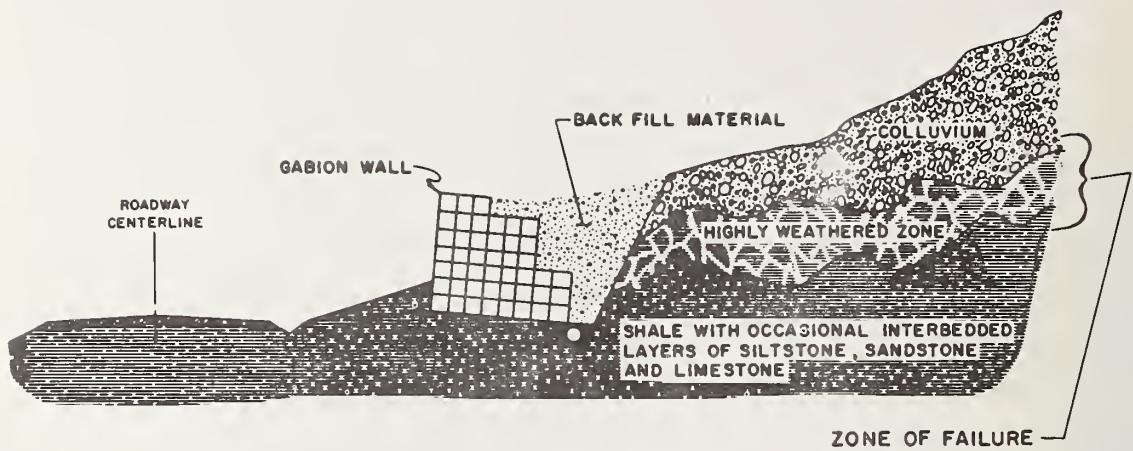
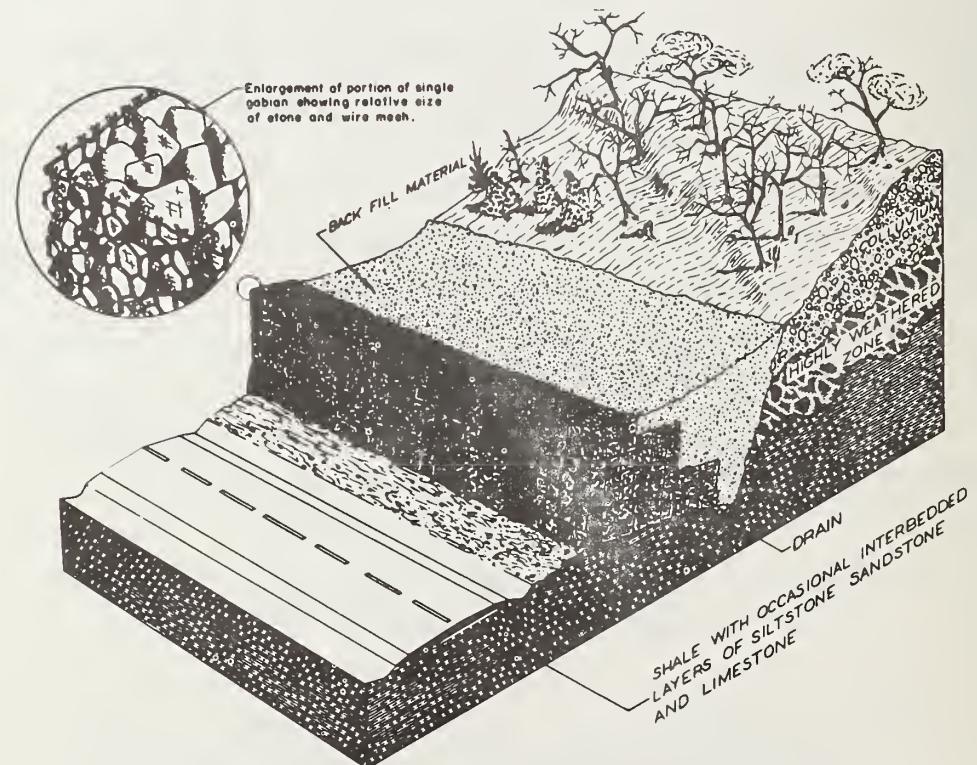
pattern with openings of about 3 to 4 in. Figure 70 depicts the manner in which several gabion walls as high as 30 ft were used in remedial treatment of slides along I-40 near Rockwood, Tennessee (Royster, 1973). The massiveness of the gabion structures and large particle size of the rock fill (4- to 8-in. pieces) are shown in Figures 71-73. The gabion wall offers advantages similar to those of the crib wall. It is free draining and can withstand large differential settlements. At Rockwood, the cost of the gabion walls was similar to or less than that of alternately proposed crib walls.

Figure 70. Gabion wall used in remedial treatment of slides along I-40 near Rockwood, Tennessee (Royster, 1973).

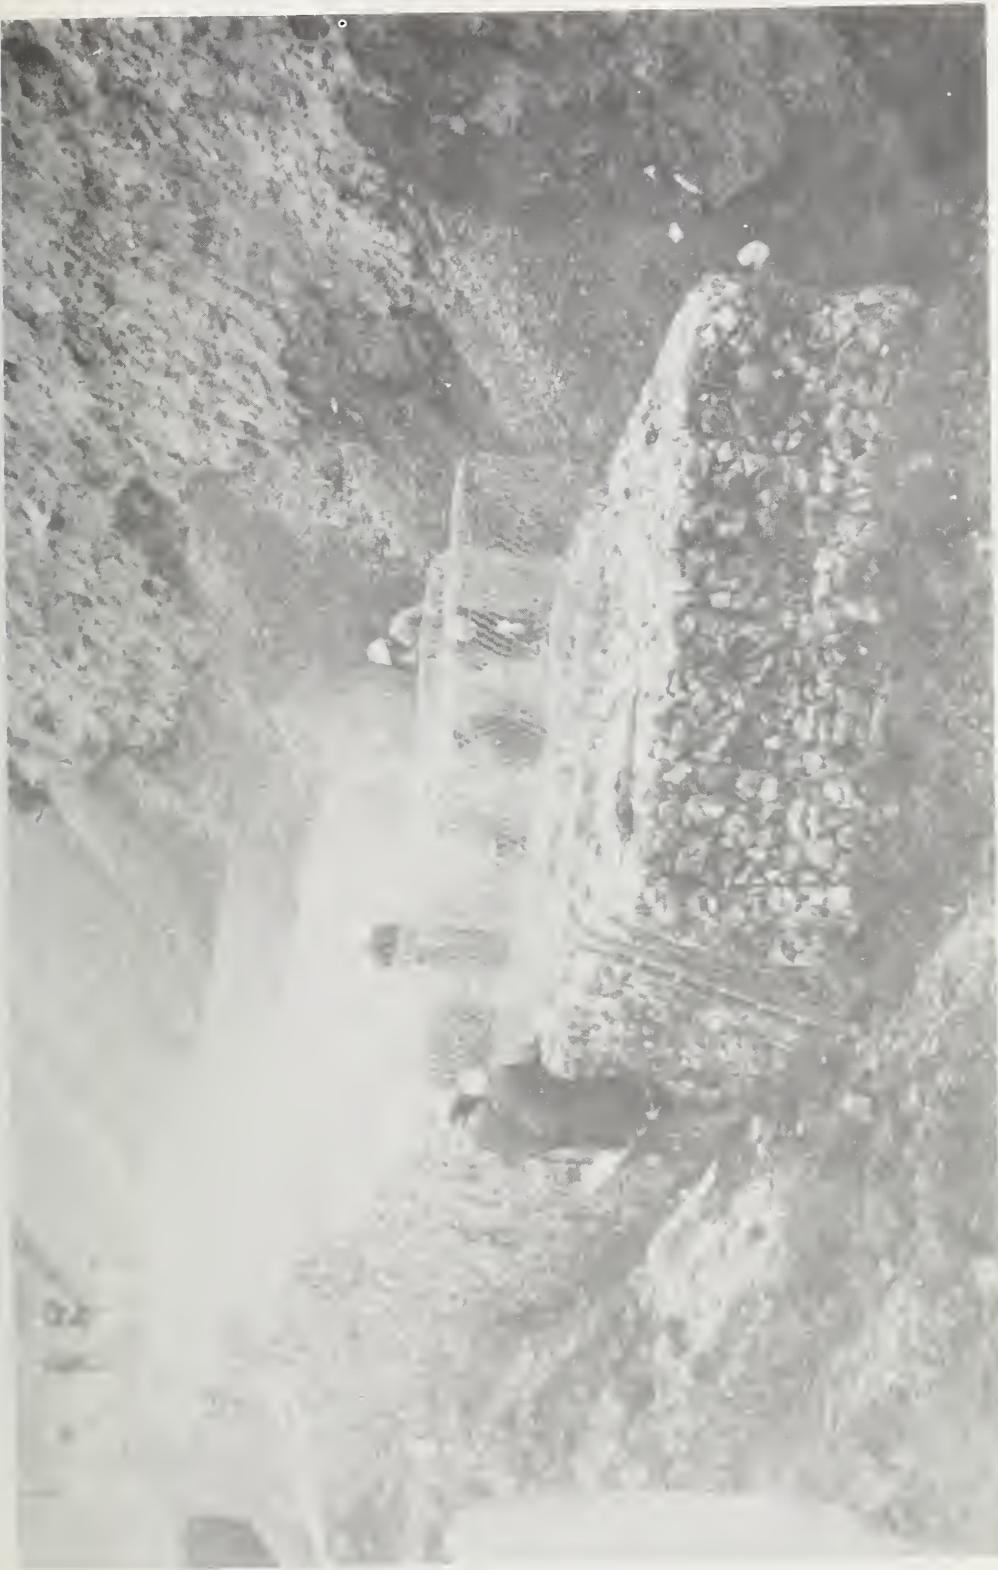
Figure 71. Gabion construction, I-40 near Rockwood, Tennessee (courtesy of Law Engineering Testing Company).

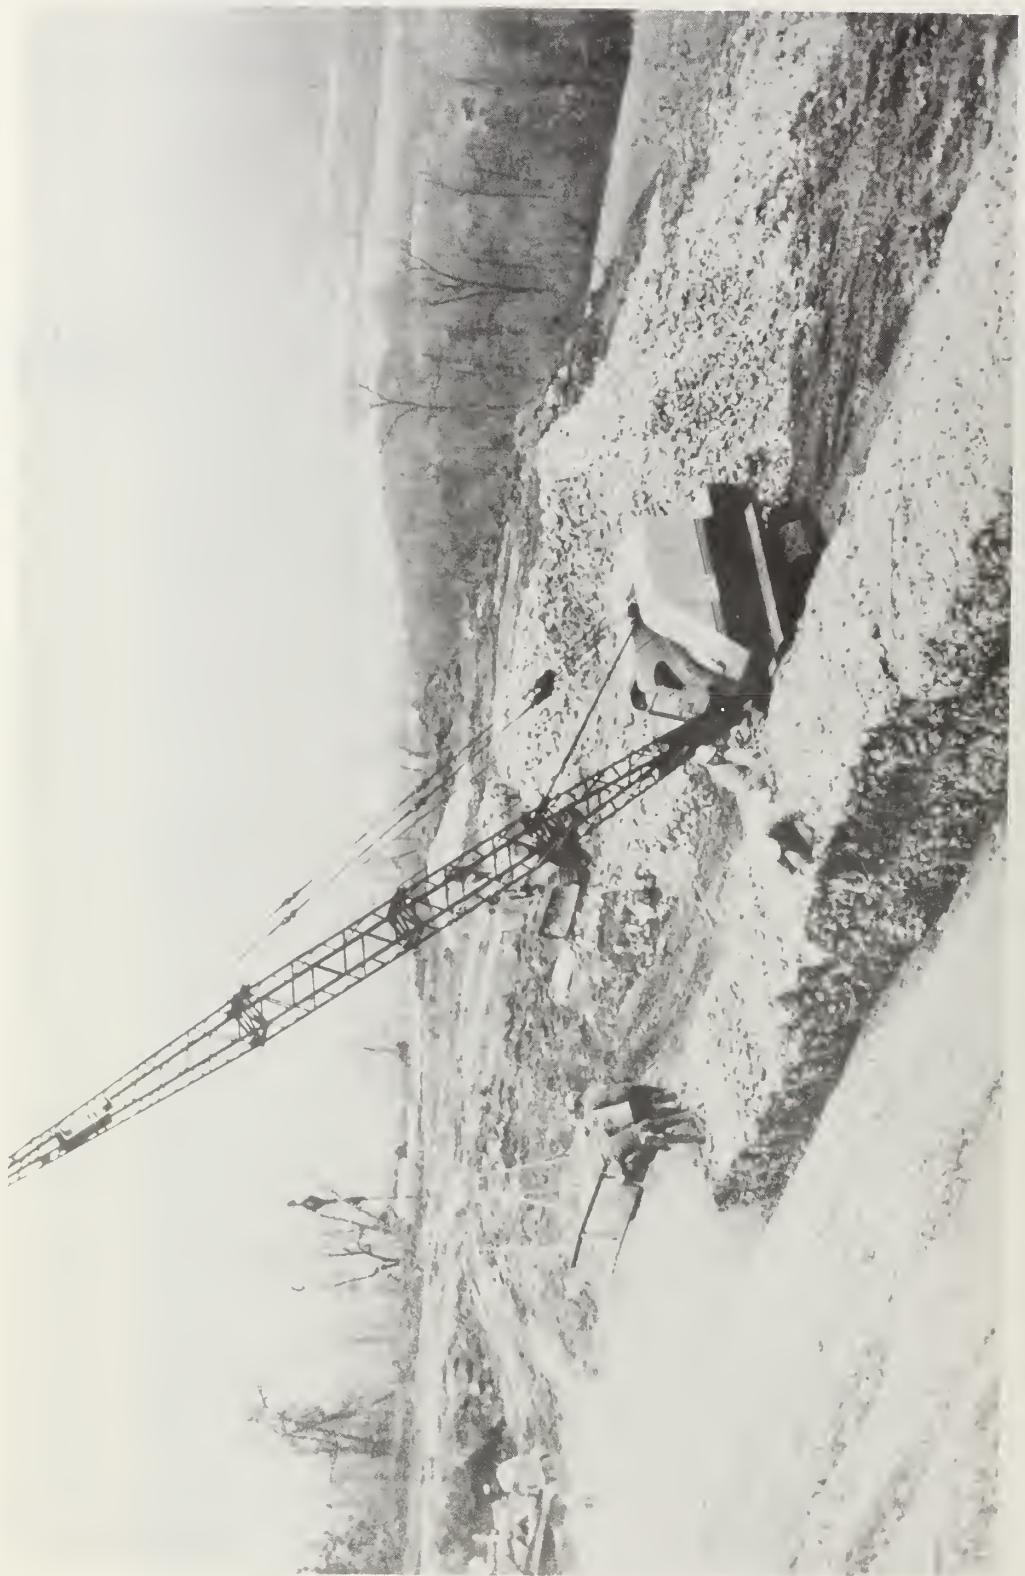
Figure 72. Gabion construction, I-40 near Rockwood, Tennessee (courtesy of Law Engineering Testing Company).

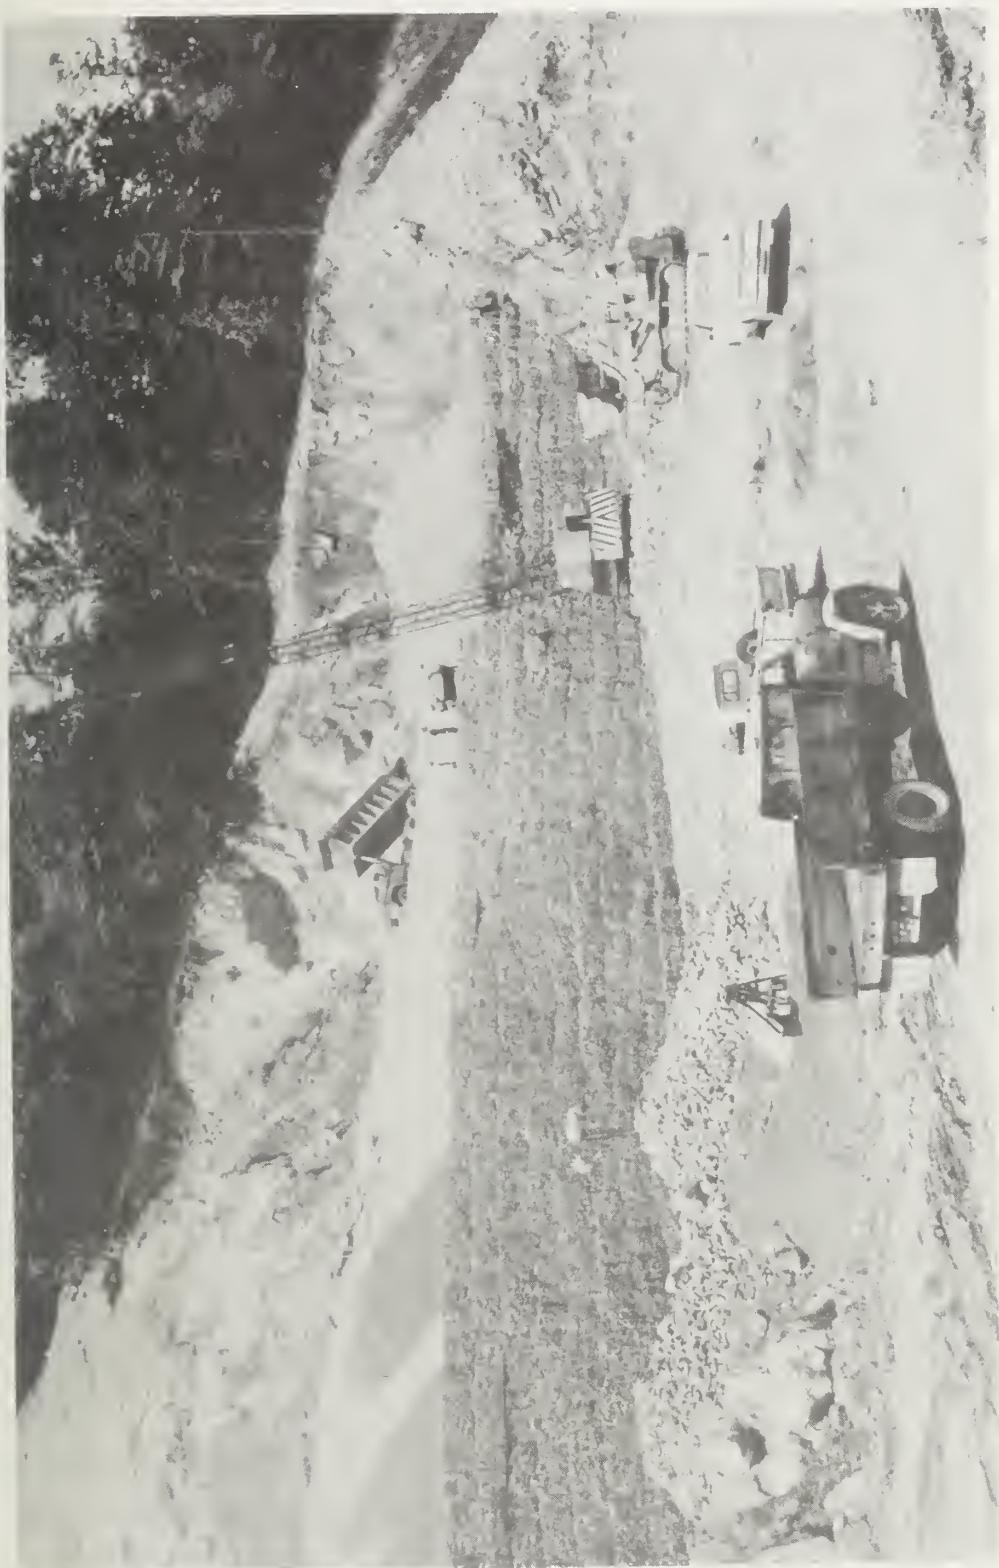
Figure 73. Gabion construction, I-40 near Rockwood, Tennessee (courtesy of Law Engineering Testing Company).

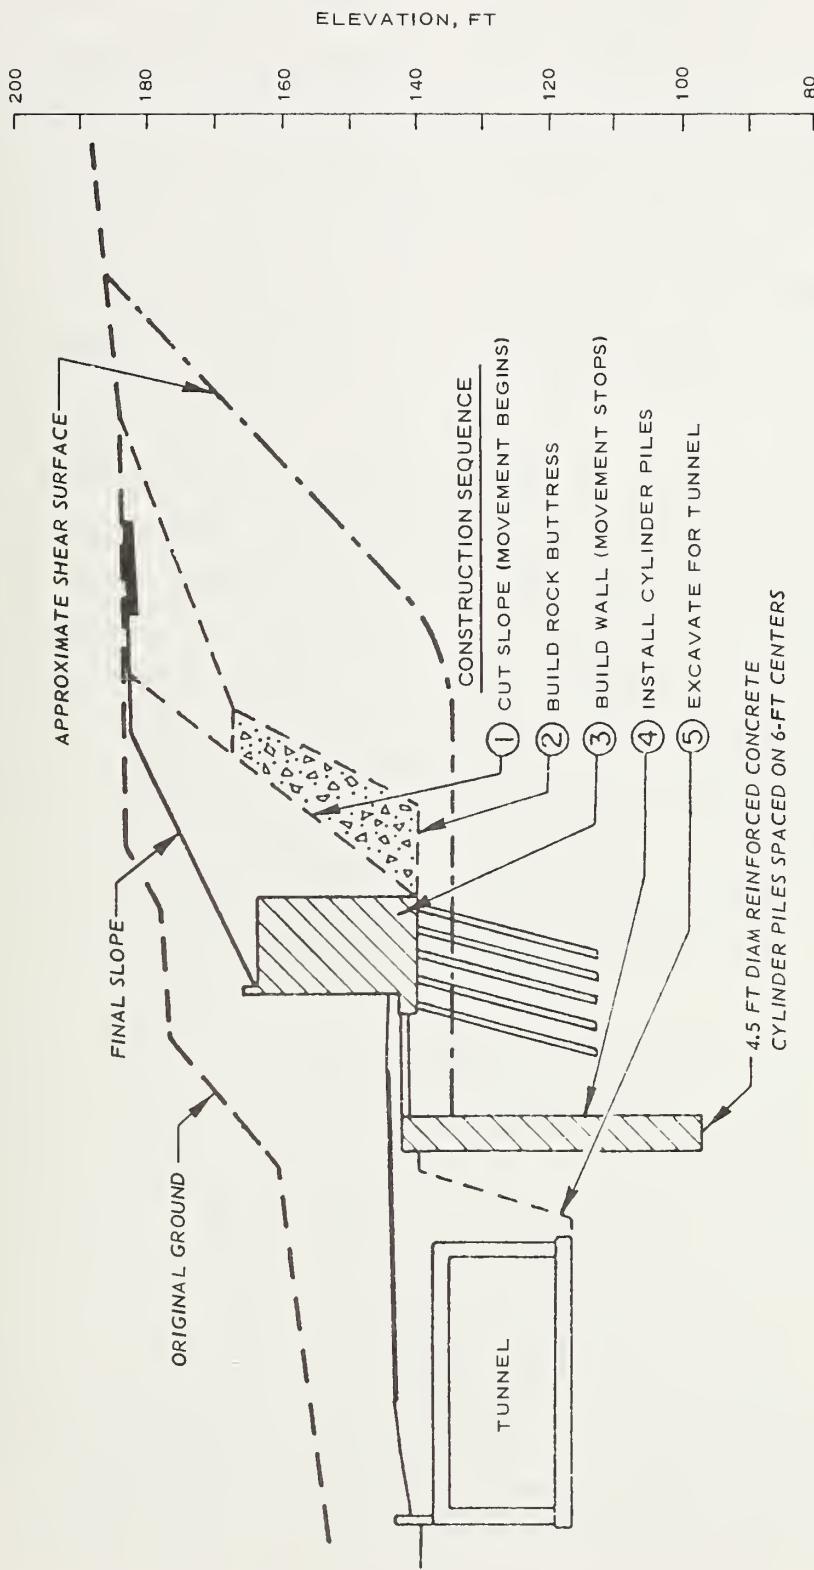
Figure 75. Stabilization of landslide by construction of a rock buttress, concrete gravity wall, and cylinder piles (Andrews and Klasell, 1964).

stabilized by construction of a rock buttress and a conventional gravity retaining wall as shown in Figure 75. Design criteria for the pile walls were set forth by Peck (1963). The design procedure consists mainly of the determination of the applied and resisting earth pressures. Each pile was designed as a cantilever member with deflections at the top of the pile dependent upon (a) magnitude of the applied loads, (b) flexural rigidity of the cylinder pile section, and (c) soil resistance developed due to displacement of the cylinder pile. Certain piles were instrumented, and preliminary studies showed that bending moments in the range of 50 to 100 percent of design values were activated (Gould, 1970).

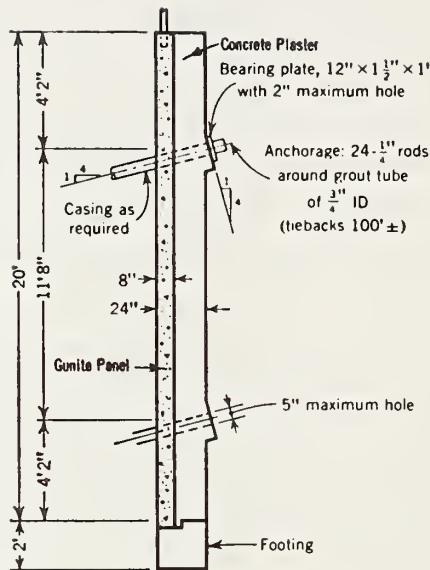
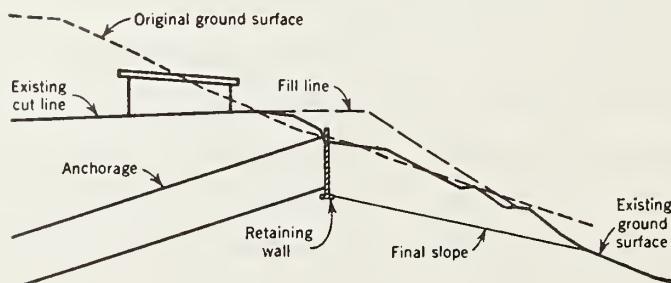
technique. In the Hollywood Hills community of Los Angeles, several homes founded on a horizontal cut section bordered by a sidehill fill were being threatened by continued movement of the slope. Various types of retaining walls (including crib walls) were considered, as were earth buttresses. The method considered most advantageous was an articulated retaining wall anchored within the hillside rock. One of the main advantages of the wall was that a retaining force could be applied immediately after construction. The wall is 20 ft high, 260 ft long, and consists of 13 independent panels, each 20 ft long. The wall panels were constructed of 8-in.-thick gunite and were reinforced as one-way slabs spanning between two vertical stiffening pilasters (Figure 76). The pilasters project 16 in. from the wall, are 20 in. wide, and are reinforced as vertical beams spanning between anchor points. At each pilaster, two tie rods, both 100 ft in length, were anchored in rock (Figure 76) through a 4-3/4-in.-diam drill hole. Each anchor consisted of 24 steel wires (1/4 in. in diameter) and was designed to be loaded in tension to 100 kips. To install the anchors, the wires were placed around a grout pipe (3/4 in. in diameter) with spacer plates between the wires. Each anchor was loaded to 150 kips for a period of 10 min. The load was then released, and the design load of 100 kips was applied. During the 150-kip test the anchors elongated about 2-1/2 in. and the wall panels moved about 3/4 in. toward the slope.

Figure 76. Remedial treatment using an anchored retaining wall (Reti, 1964).

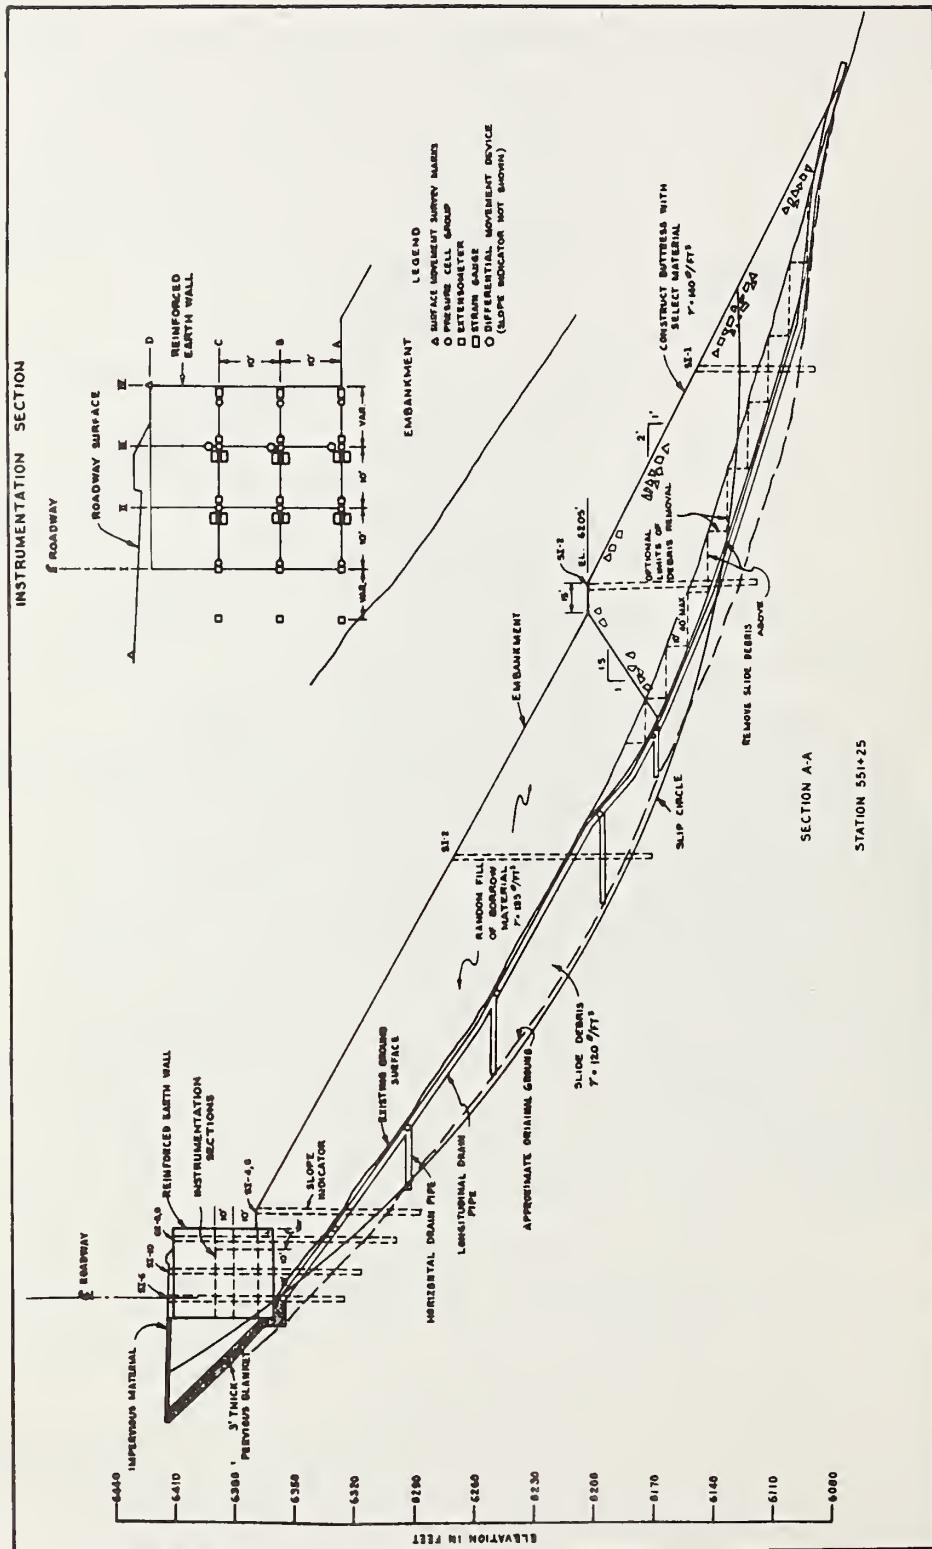
Route 39, California. The first reinforced earth wall in the United States was used in the reconstruction of a section of Route 39 near Crystal Lake in the San Gabriel Mountains, Los Angeles County, California (Chang et al., 1972b; Gedney, 1972; Chang et al., 1974). The highway is supported by the reinforced earth wall which is constructed over a random fill embankment founded on slide debris. A toe berm (or buttress) was built at the bottom of the slide debris to support the embankment fill and natural slope as shown in Figure 80. The reinforced earth wall has a maximum height of 55 ft and a length of 528 ft. An extensive drainage system consisting of a 3-ft-thick permeable interceptor blanket placed behind the wall in combination with buried pipe drains was used to remove subsurface seepage as shown in Figure 80.

Figure 80. Reconstruction scheme employed on Route 39 near Los Angeles, California (Chang et al., 1972b).
